# Accident / Incident Report Closed

Unit/Department	Process Area	Site	Report Number				
North Operations-Elyria	Tableting - Building 10	ELYRIA	0084-NOPS-14-0092				
Report Date	Incident Date	Incident Time	Copied From				
07/17/2014	07/16/2014	09:45 AM					
Incident Location	Team Leader / Supervisor	Reported By					
Building 10 ammonia scrubber.	Terrence M Vanderbosch	Douglas A Jordan					
Title of Event (Limit to 90 characters)	Category	Division / Bus. Group / Subgroup Code					
Ammonia scrubber malfunction	<input type="checkbox"/> Safety & Health <input type="checkbox"/> Environmental	CC / G-CCP					
Incident Classification							
<input type="checkbox"/> Near Miss <input checked="" type="checkbox"/> Process Safety <input type="checkbox"/> Injury / Illness <input checked="" type="checkbox"/> Spill / Release <input type="checkbox"/> Permit / Regulatory Deviation <input type="checkbox"/> Fire <input checked="" type="checkbox"/> Odor Complaint <input type="checkbox"/> Property Loss <input type="checkbox"/> Citation / NOV <input type="checkbox"/> Health Exposure <input type="checkbox"/> Inspection <input type="checkbox"/> Major Incident <input type="checkbox"/> Non-Occupational <inpu

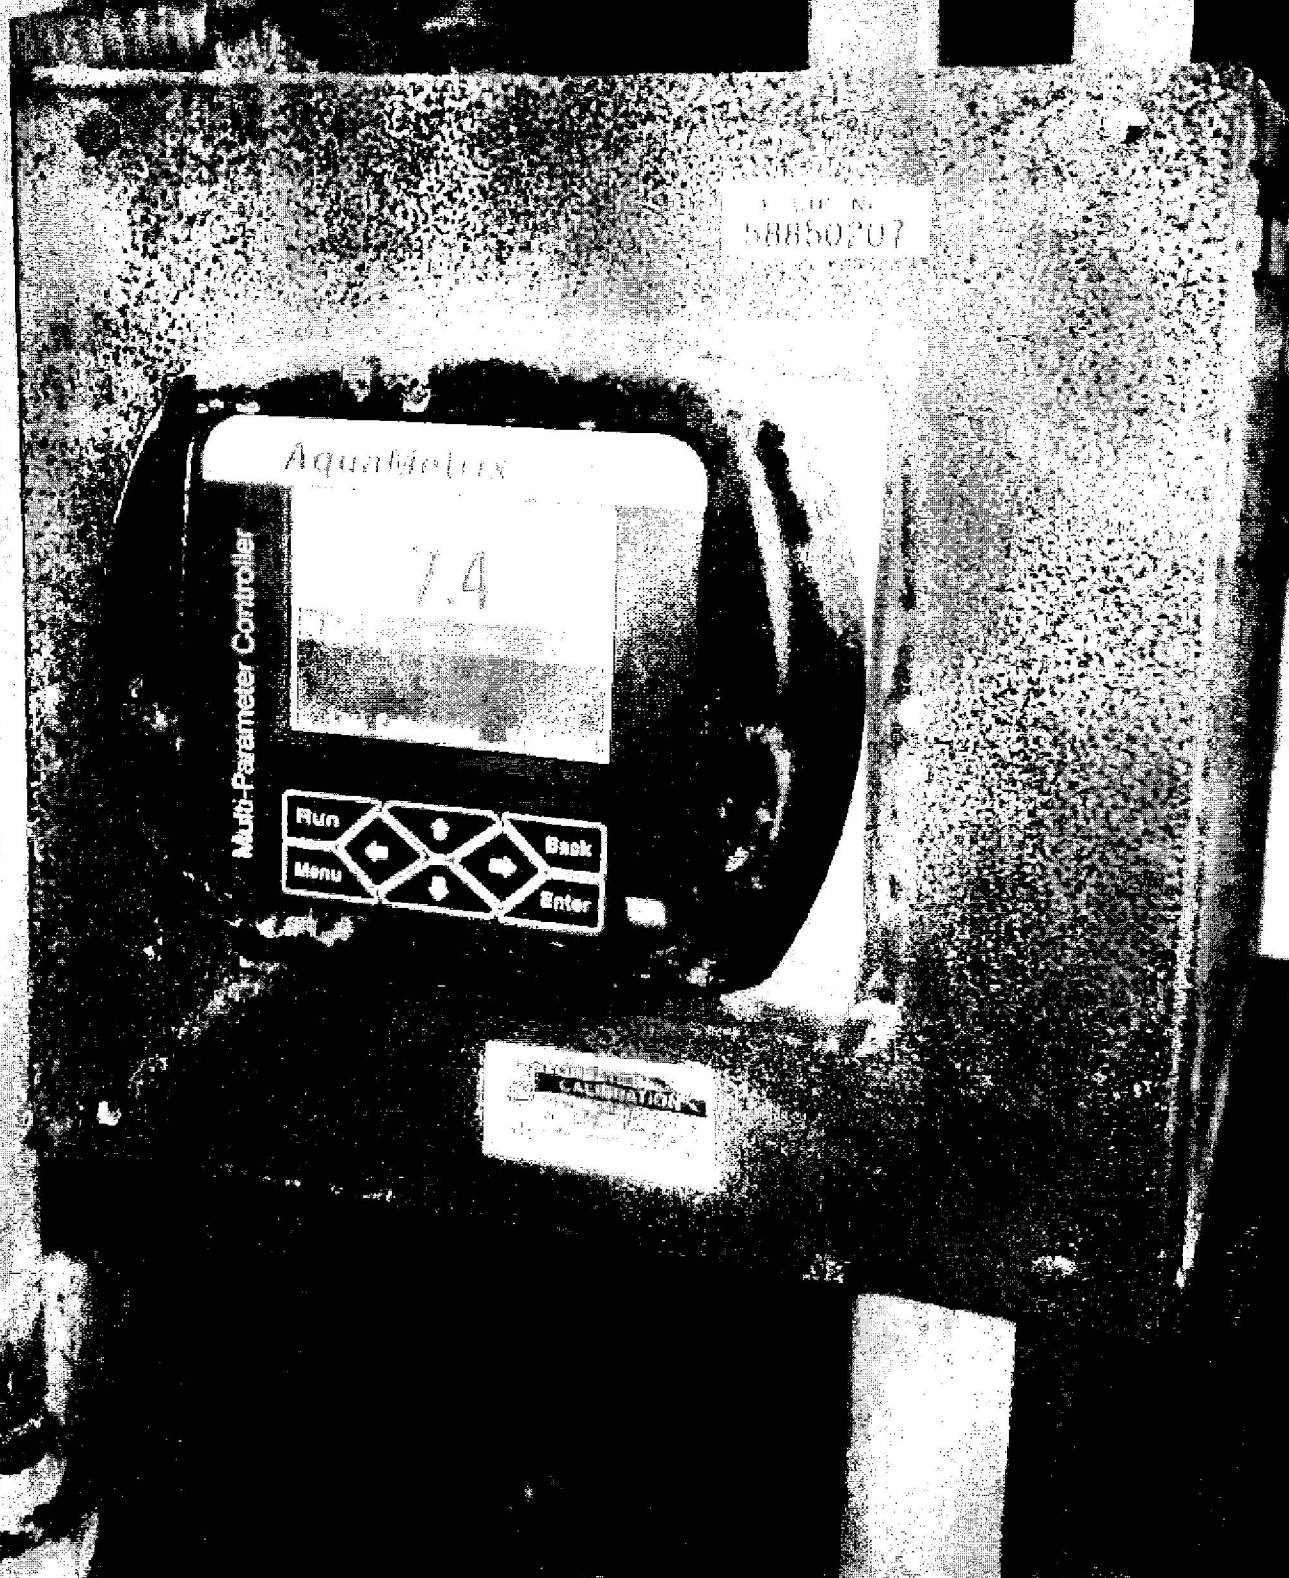
Describe Event / What Happened			
<p>While doing inspections for the General Catalyst Department it was noticed that a haze was hanging in the air on the East side of the building, upon inspection it was found that F2 scrubber discharge stack was blowing out a haze toward the east side of the building. The scrubber was inspected and the level was good and the pump was showing a flow of 90 gal/min. The pH probe was showing a 7.3 reading. The tank was then tested with pH paper and found that it was at a 0 pH. The make up water was turned on and the tank was drained out and refilled to try and increase the pH of the scrubber water. The scrubber was brought up to approximately a 5 pH and then the stack was reinspected only to find it still blowing out a haze. Some condensate from the stack was also tested with some pH paper and found to have an extremely low pH as well, 0-1. The system was then shut down to prevent further discharge. This scrubber is being used to draw vapors off of tank 6 and 7 while we have been reducing Nickel Nitrate to a 17% solution concentration in the tanks. Please note that the pH controller is only for display purposes it does not maintain the flow of chemicals to maintain a set pH on this scrubber.</p>

Item	Corrective Action(s) to prevent recurrence	Responsible Person	Target Date	Final Closed Date	VC Req	VE Req
1	Identify an engineer to review the maintenance files/documentation for F2 scrubber to determine and document operating parameters. Add an action item into the system.	Noemi Trent/BASF-CATALYSTS/BASF	10/12/2016	11/02/2016	N	N

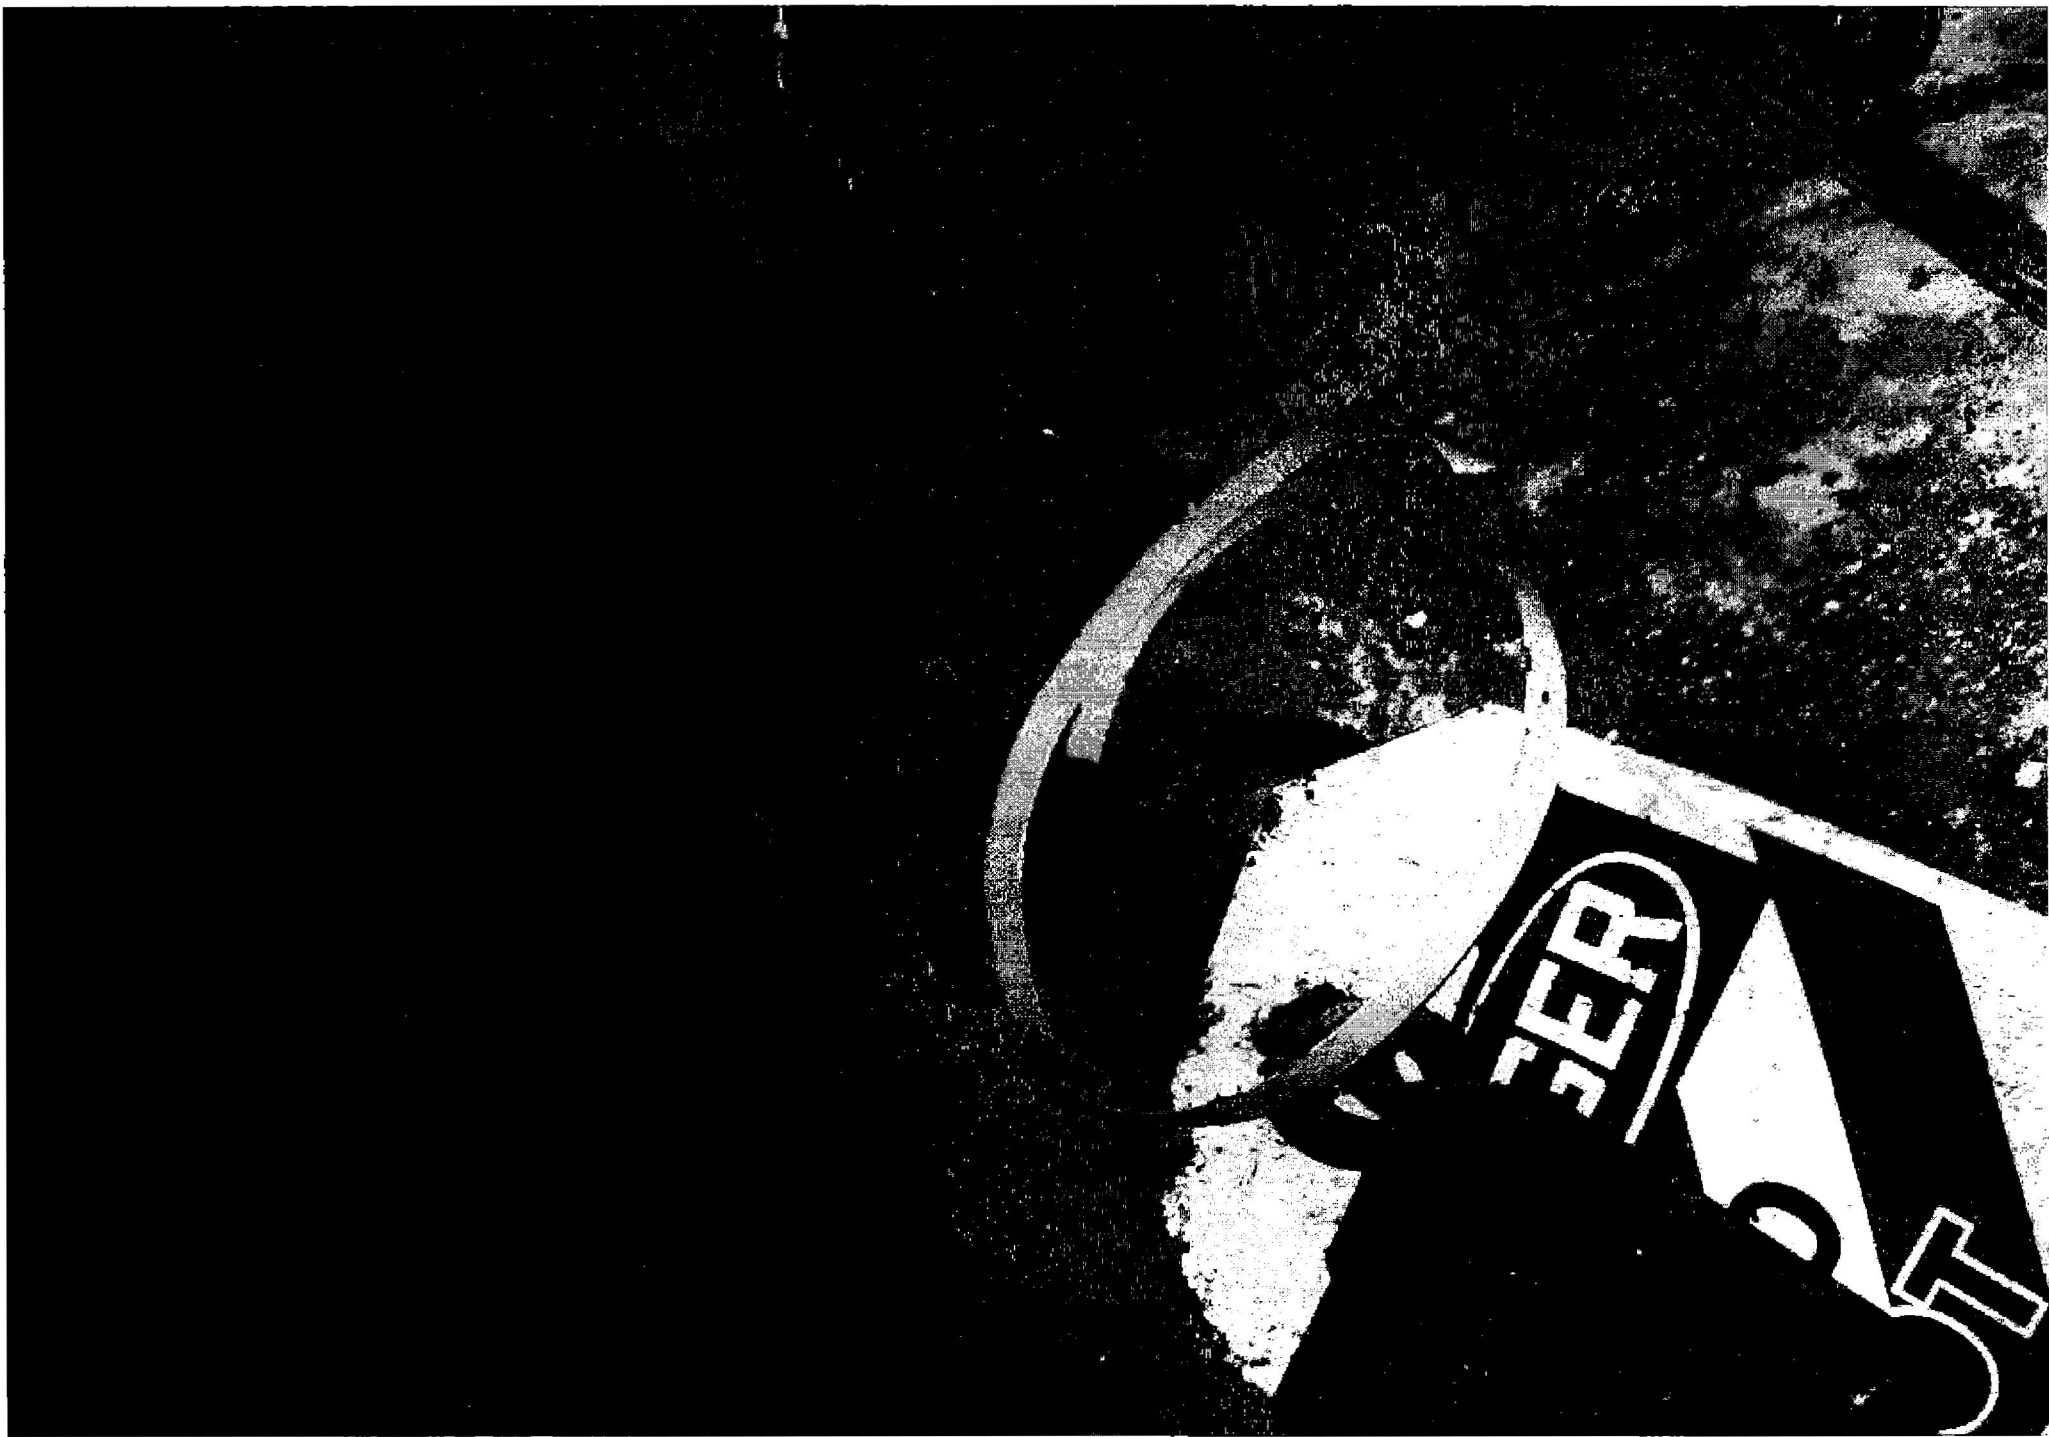
While doing inspections the shift supervisor noticed a haze outside of building 31 at the 3rd floor east roof access door. Upon investigation a visible discharge was noticed coming out of the discharge stack for #8 Dust Collector. The dust collector was immediately turned off and locked out to inspect the bag house. While locking out the unit it was noticed that one of the banks of the blowdowns is disconnected. The bags were inspected and the stage that the blowdowns were turn off on had an excessive buildup of powder on them. Three bags were identified as damaged. In addition, it was determined that the dust collector was backed up. The unit was inspected earlier in the day at 5pm with no visible discharge. This unit is used for dust collection for #1 hopper, Spiral elevator, Extruder, and the east Pfaudler loading station.

Contributing Causes	Root/Primary Causes		
The corroded or plugged blowdown was not fully repaired which allowed for excessive build up on the bags.	28 - Equipment Reliability Program Implementation LTA	29 - Corrective Maintenance LTA	31 - Repair Implementation LTA
Rotolock was not allowing powder to empty out of the dust box which allowed for excessive powder build up.	138 - Human Factors Engineering	160 - Intolerant System	161 - Errors Not Detectable

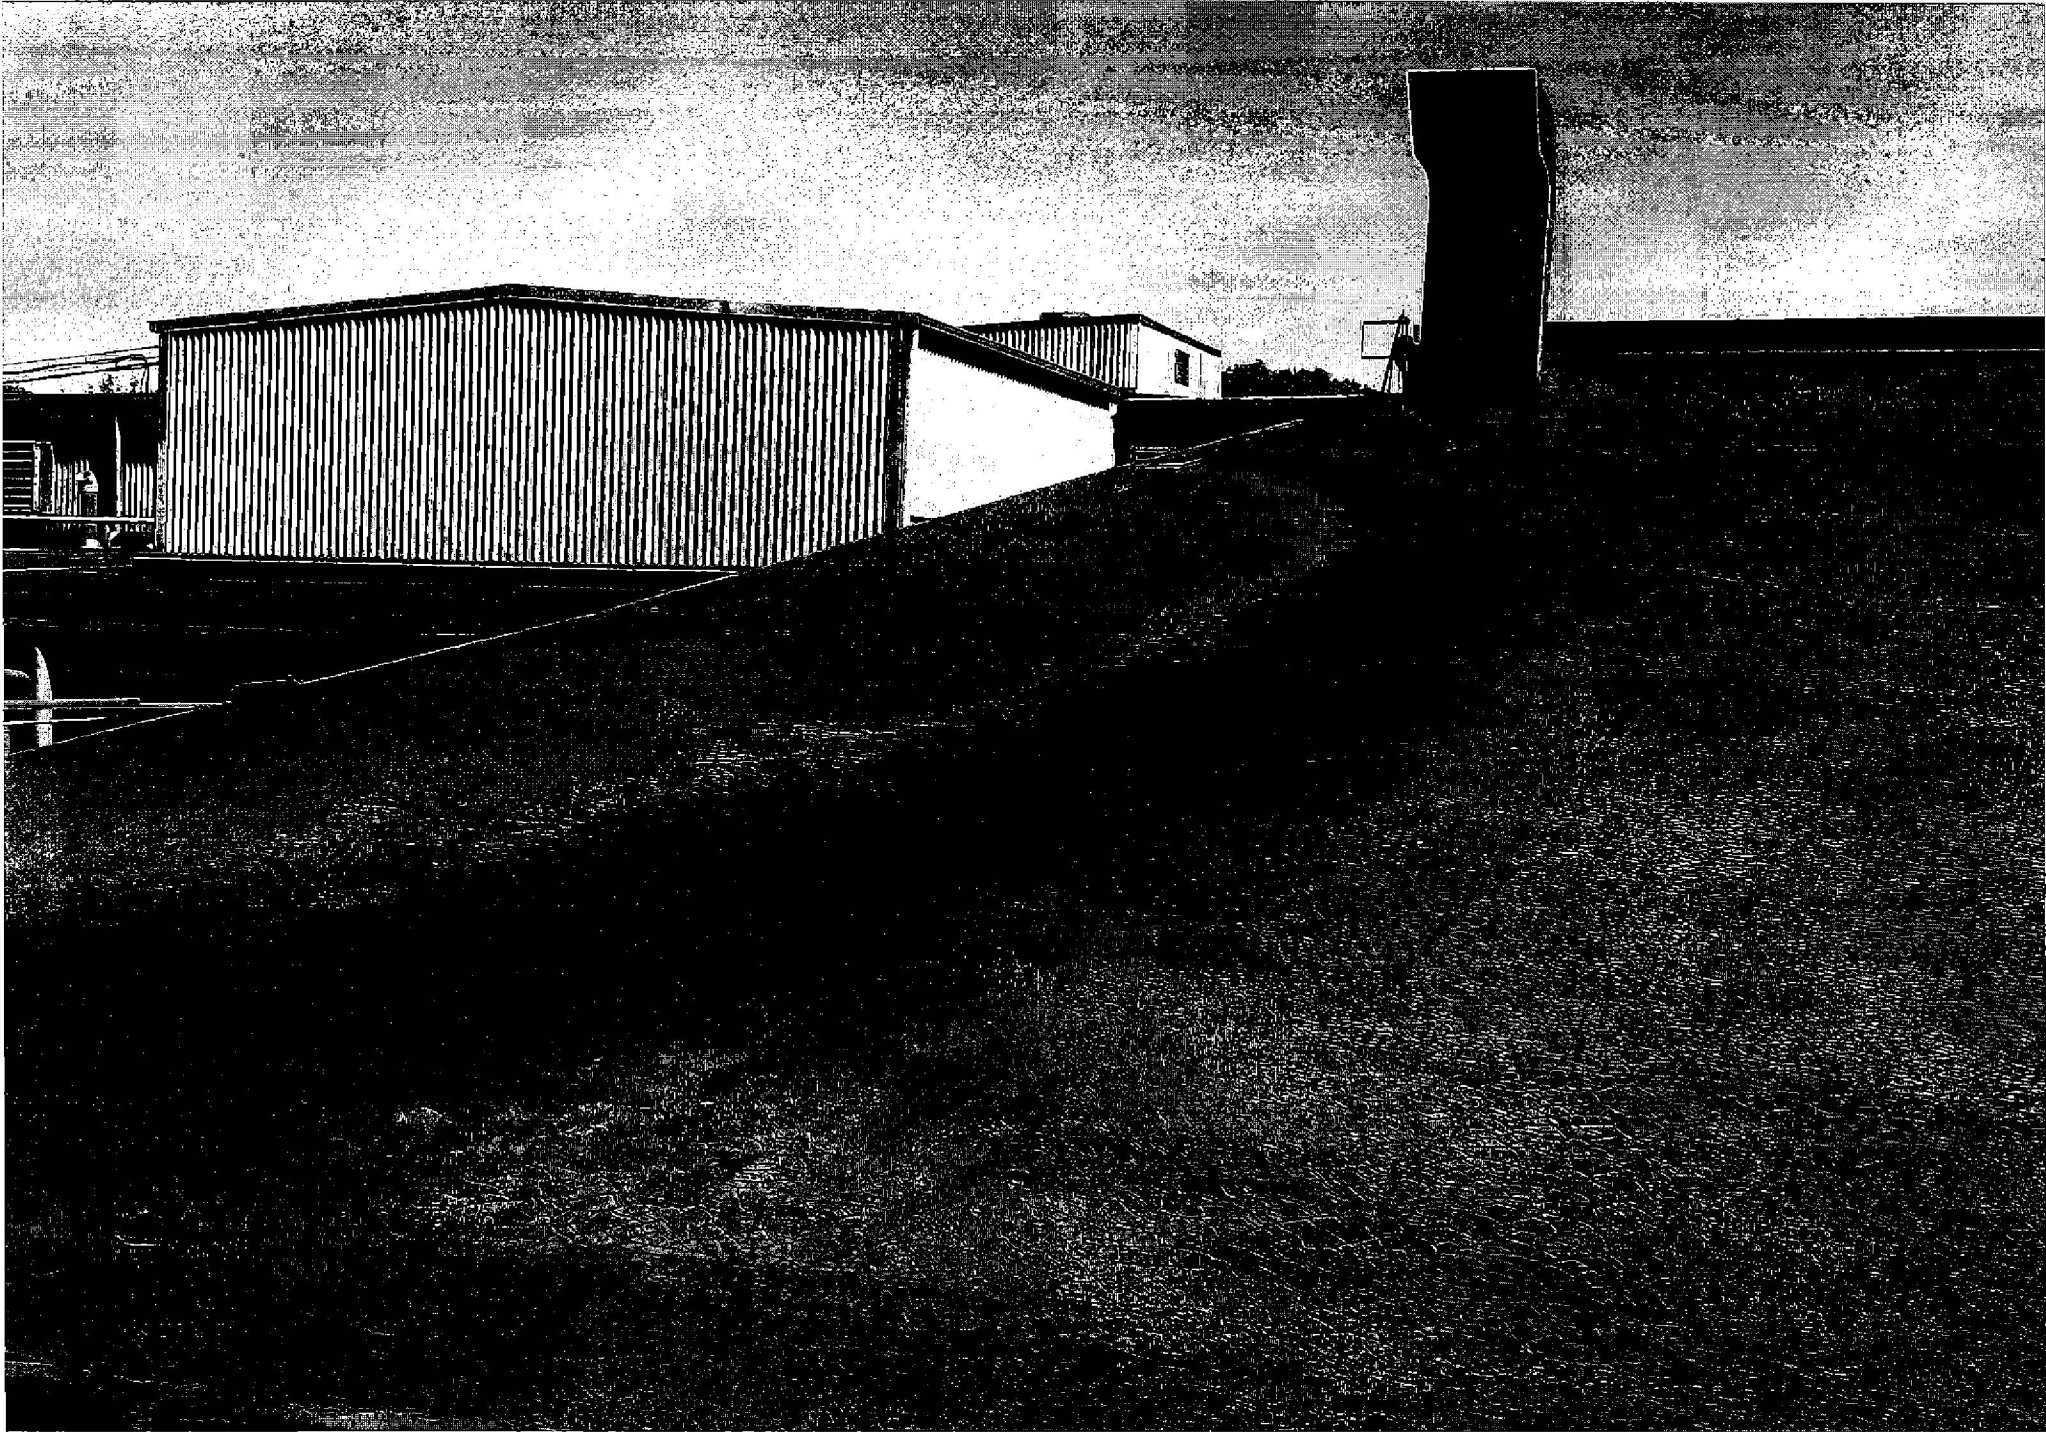
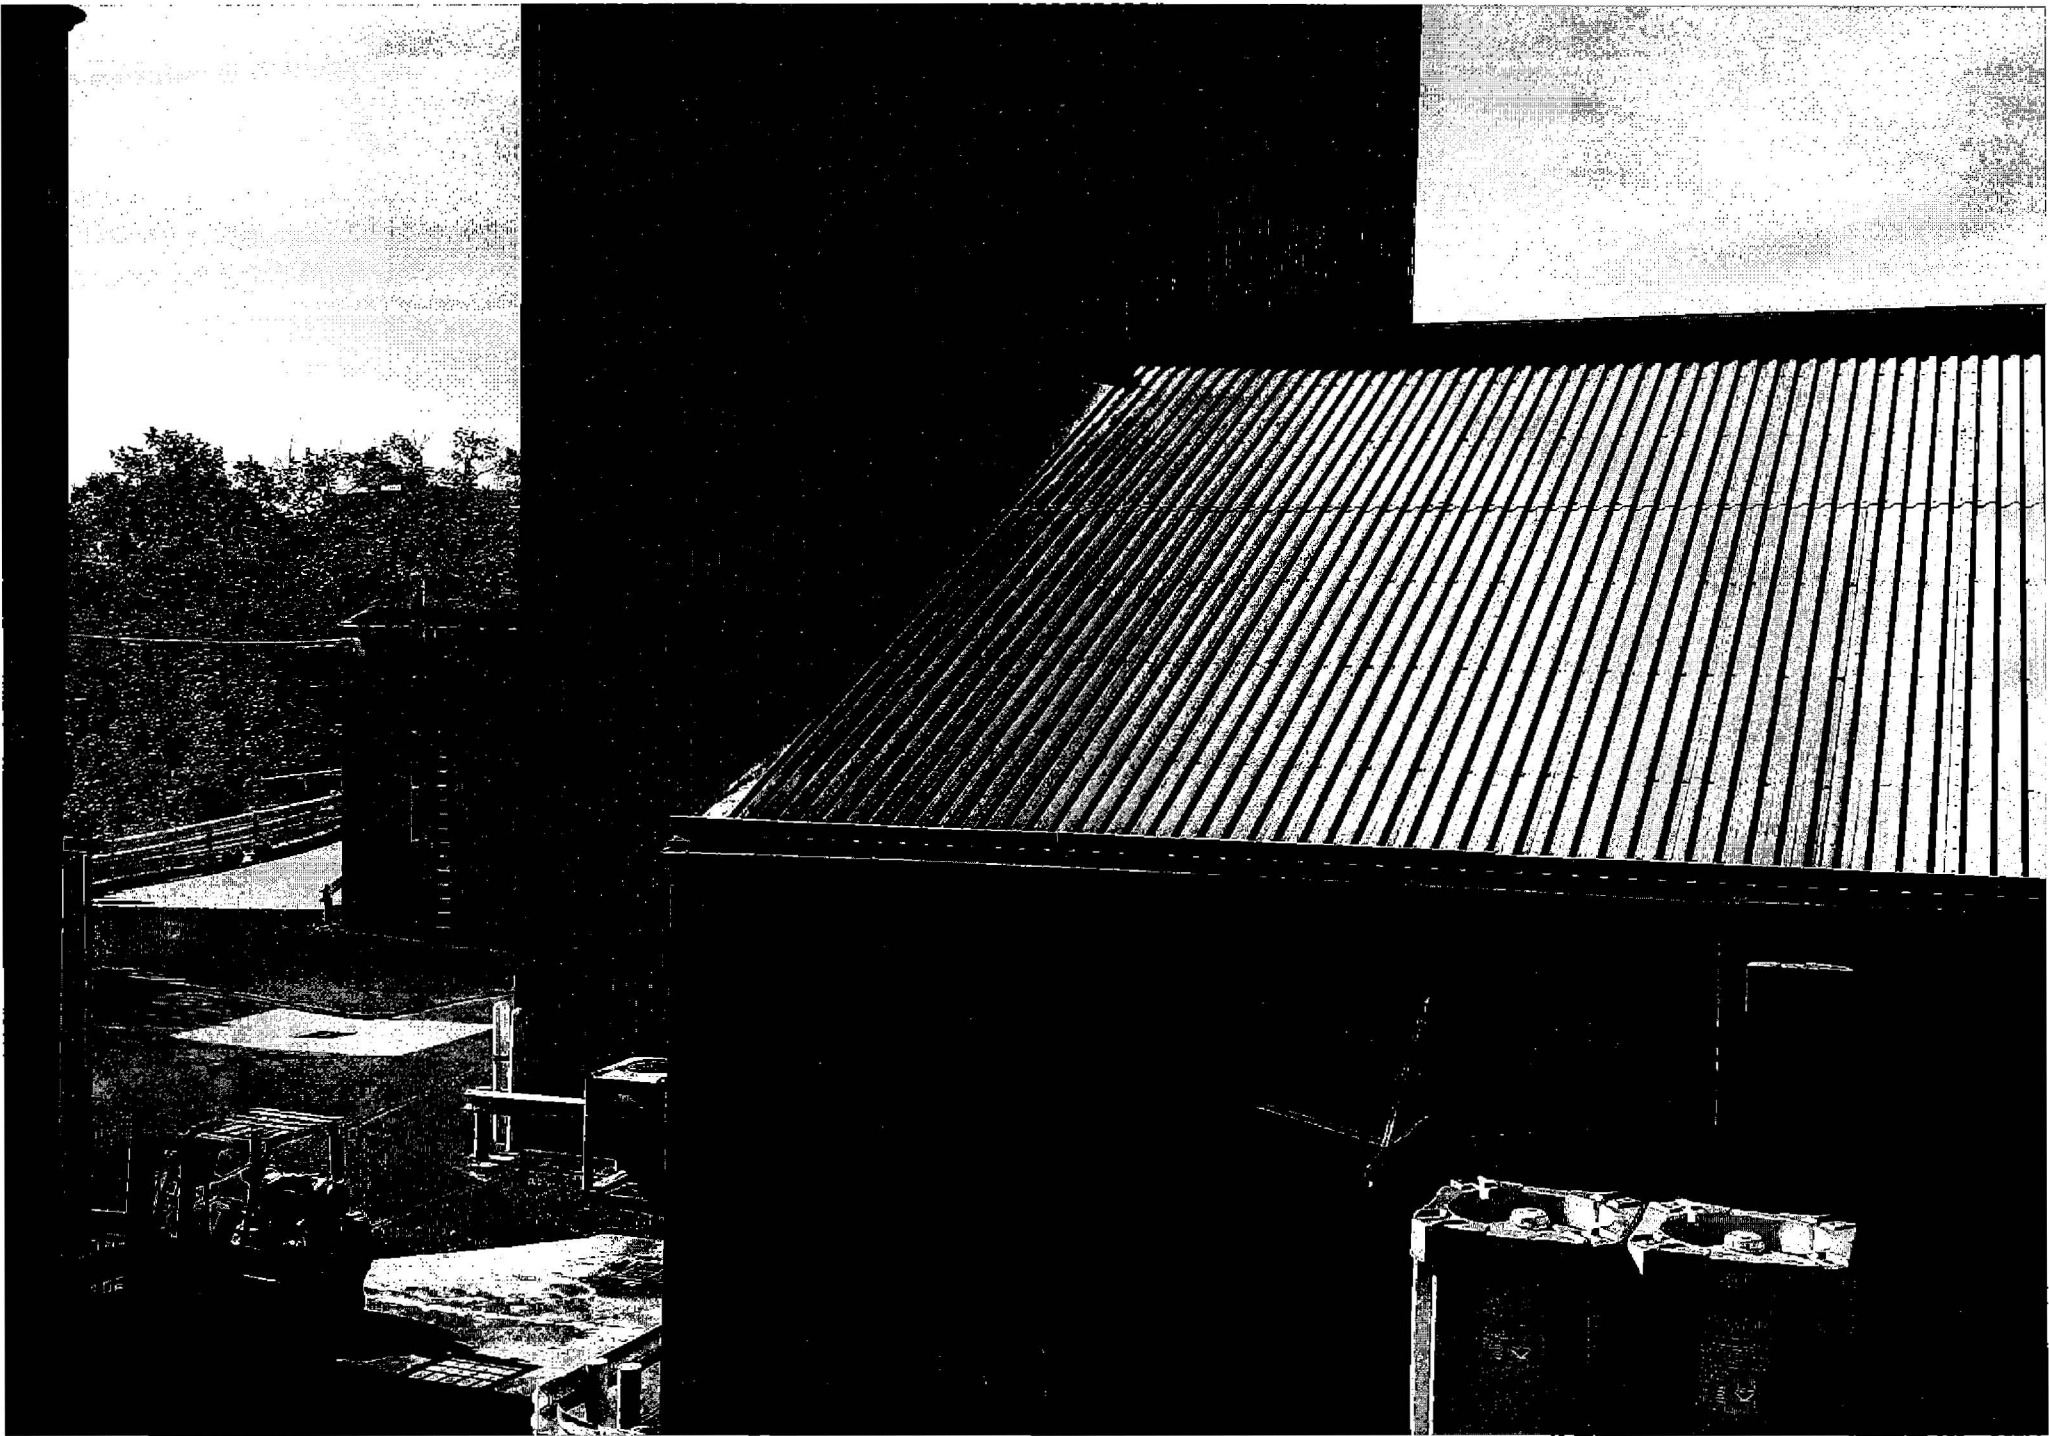
At the beginning of the shift it had been reported that powder was found in the small alleyway between building 7 and building 10 (East of both buildings). Upon investigation it was discovered that the black powder was not only found in the alleyway but also on the roof of building 10 (see attached picture) and building 7 (see attached picture). As a precaution we closed the north end sluice gate and began our clean up efforts. Additional investigation and quick interviews with veteran employees pointed at the BI mill dust collector as the possible source. While cleaning the area GL Navarro opened two cartridge receptacles on the dust collector for a quick view and discovered that at least one of the cartridges had been installed backwards - see attached picture.

Still under investigation but it would appear that the installation of at least one of the cartridges backwards may have been the cause.

It appears that at least one of the cartridges replaced on the dust collector used at the BI mill for V-2046 was installed backwards.

Contributing Causes	Root/Primary Causes		
Unable to determine if operator was properly trained in how to install the cartridges in the dust collector.	163 - Training	170 - Training LTA	175 - On-the-Job Training LTA
There isn't a procedure readily available that describes the proper installation / orientation of the Torit bag house filters at the BI mill area in building 10.	111 - Procedures	112 - Not Used	116 - No Procedure for Task
